**Rose Energy Project: Survey for Eurasian Otter *Lutra lutra* activity along a 200m section of the Glenavy River, County Antrim**

**April 2008**

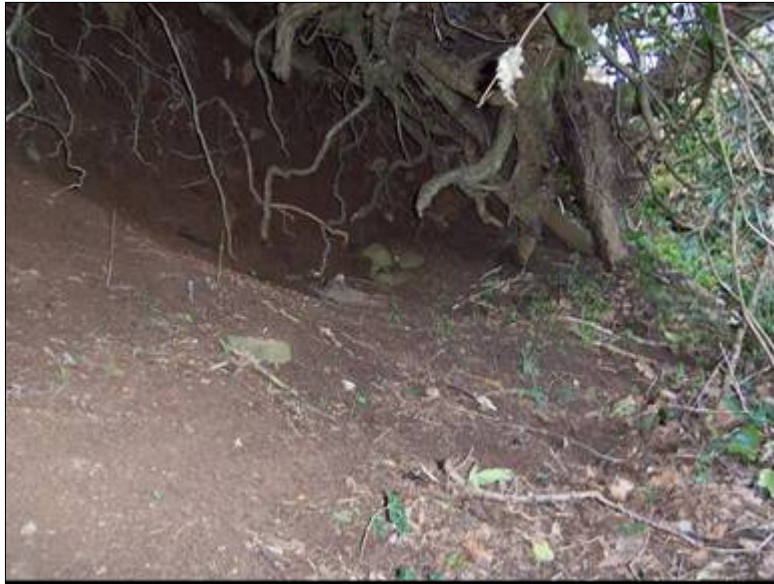
- 4.1 The area surveyed demonstrated a high level of otter activity in the form of fresh spraint (otter droppings), slides and holts.
- 4.2 Eight spraints were found during the survey, four of which were very fresh. Two spraints were found on boulders in the river; five were found in a couch area under a cavity formed by erosion under tree roots (Plates 1 & 2), and one spraint was found at the entrance to an otter holt (T3, Figure 2).

**Plate 1.** A large cavity in the river bank formed by erosion under tree roots, which acted as a couch area for otters, with an otter slide into the river (Grid Ref: IJ 12939 72658 ± 6m)

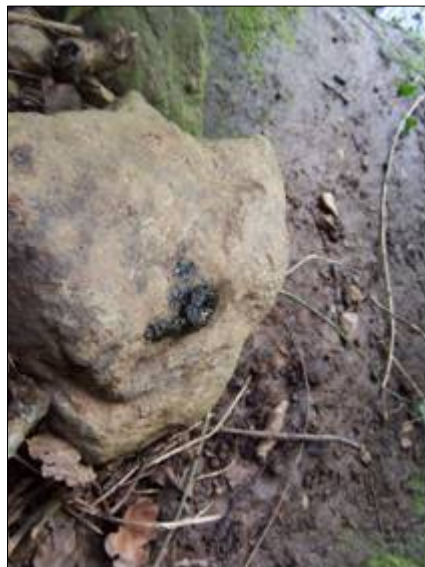
**Plate 2.** Fresh otter spraint on boulder between couch in Plate 1 and slide to river (right of boulder)

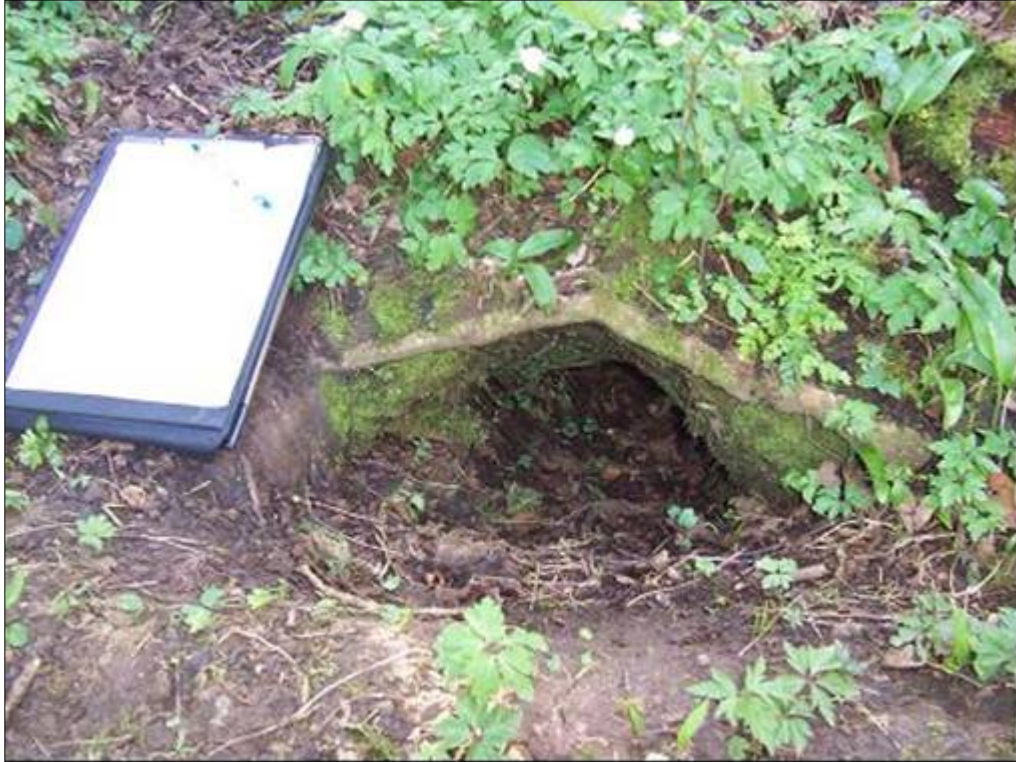
- 4.3 A single entrance Eurasian badger *Meles meles* sett was detected along the river bank (Grid Ref: IJ 12966 72647 ± 6m) (Plate 3; **T1**, Figure 2). This burrow represents an outlier sett, and although there were no signs of activity at the sett during the current survey, it was deemed to have been in use within the last year.

**Plate 3.** A Eurasian badger outlier sett

- 5.2 Despite the badger sett being deemed as inactive at the time of survey, this refuge is still protected under legislation. The ecology of the Eurasian badger is such that an outlier sett may be used sporadically by badgers. The high level of badger activity noted in the surrounding fields (in the form of well-worn pads, snuffle-holes, foraging disturbance, and other nearby setts (as per MARENCO's wider ecological survey findings for the area), suggest that the outlier sett in question, lies within an occupied badger territory, and therefore could be used by badgers at any time.

- 5.4 It is important that the laying of the proposed outlet pipe does not impact upon the badger sett, the otter holt, or the third burrow which lies in between. It is therefore recommended that the pipeline is laid at a distance no less than 30 metres to the east of the badger sett in order to comply with legislation. In relation to the otter holt, it is currently uncertain what distance specifications and exclusion zones are relevant to otters under the terms of the Conservation (Natural Habitats, etc.) (Amendment) Regulations (Northern Ireland) 2007. It is likely to depend on the status of the individual holt (i.e. breeding) and clarification is being sought from the Wildlife Officer of the Environment and Heritage Service. It may be necessary to apply for a licence relating to potential disturbance of the otter holt during any works, including pipe laying operations, which occur within proximity to the otter holt and further clarification on this matter should be sought from the Wildlife Officer.

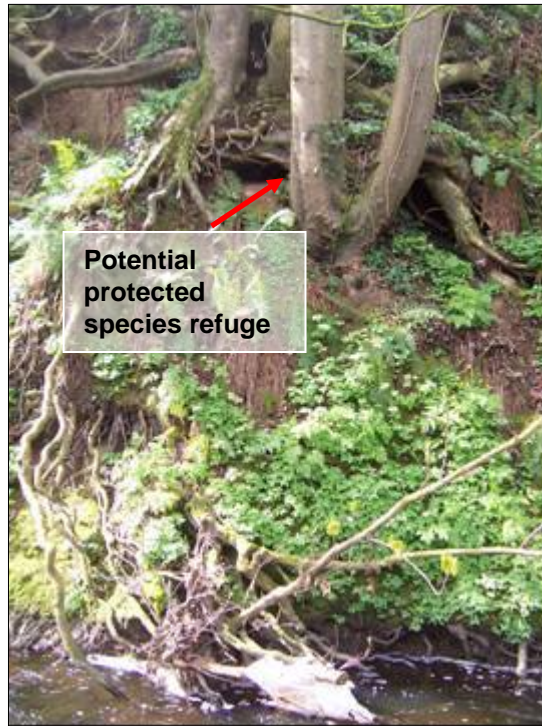
- 4.4 A large burrow was noted in the river bank (Grid Ref: IJ 12935 72660 ± 6m) (Plate 4). It was not possible to access this burrow for close inspection due to the precipitous nature of the river bank both above and below the burrow. Mammalian pads were noted along the bank accessing the burrow, which suggested that mammals as large as otter or badger may have access to this burrow. Due to the proximity of this burrow to both a badger sett (**T1**, Figure 2) and an active otter holt (**T3**, Figure 2), it is deemed prudent as a precaution to classify this burrow as a potential refuge for protected species.

**Plate 4.** Burrow inaccessible without climbing equipment (T2, Figure 2). Potential otter holt / badger sett.
